AEROSPACE RECOMMENDED PRACTICE

ARP6225™

(R) Aircraft Tire Inspection - In-Service Removal Criteria

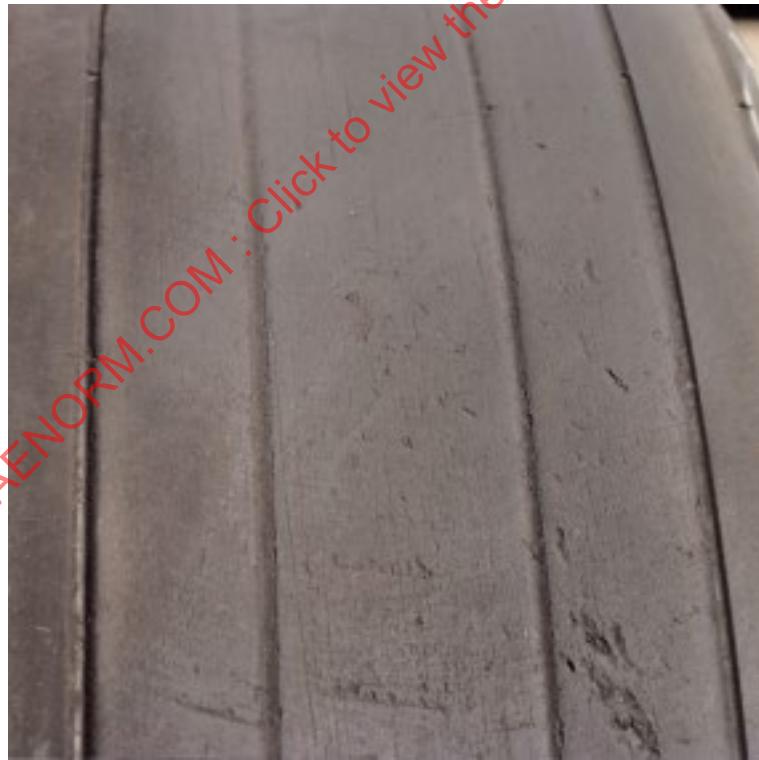
Figure 3 - Normal wear

An even tread wear indicates that the tire has been properly maintained during its service life.

REMOVAL LIMIT: Remove tire when the bottom of any groove at one point up to 1/8 of the tire circumference is reached (Figure 3), or when any fabric or metallic material is exposed at any location over the tread surface, WHICHEVER COMES FIRST (Figures 4 and 5).

NOTE: If the wear removal criteria is met at an outstation where maintenance is not available, the aircraft manufacturer should be contacted to assure the tire may remain in service and if any additional tire inspections are required prior to each aircraft departure before arriving at a suitable maintenance base for a wheel and tire assembly replacement. This should be accomplished as soon as possible. However, if any fabric or metallic material is exposed, the tire should be removed immediately.

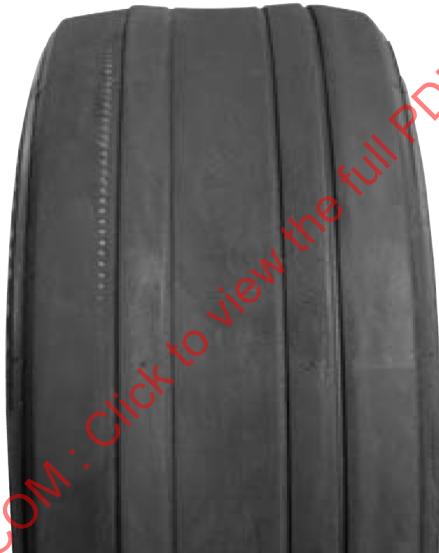
Figure 4 - Shoulder wear

Under-inflation can lead to excessive tread shoulder wear. It will lead to high tire deflection and subsequent heat build-up, which may result in severe tire damage. The cause for operating underinflated should be investigated by the operator and corrective actions taken (Figure 4). Underinflated tires should be corrected per the tire maintenance schedule of ARP5265 and the AMM.

REMOVAL LIMIT: Tires with uneven wear should be removed from the aircraft if the wear limits (defined under normal wear) are reached.

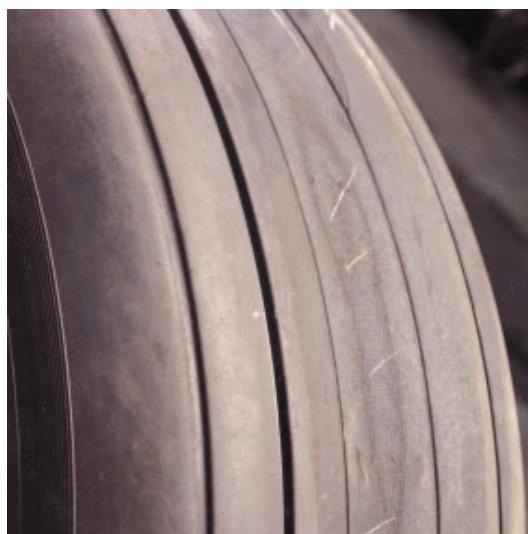
Figure 5 - Center wear

Over-inflation can accelerate the center tread wear, reduce tire traction, reduce the number of landings per tread, and make the tire more susceptible to cutting and foreign object damage (FOD) (Figure 5). Overinflated tires should be corrected per the tire pressure maintenance schedule of ARP5265 and the AMM.

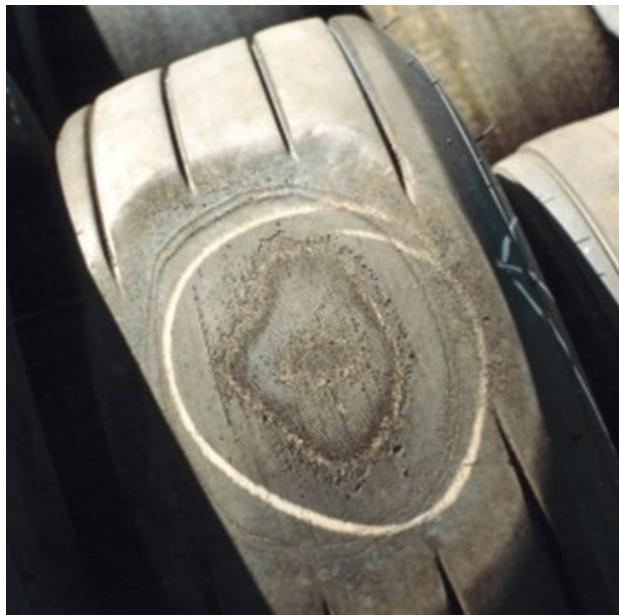
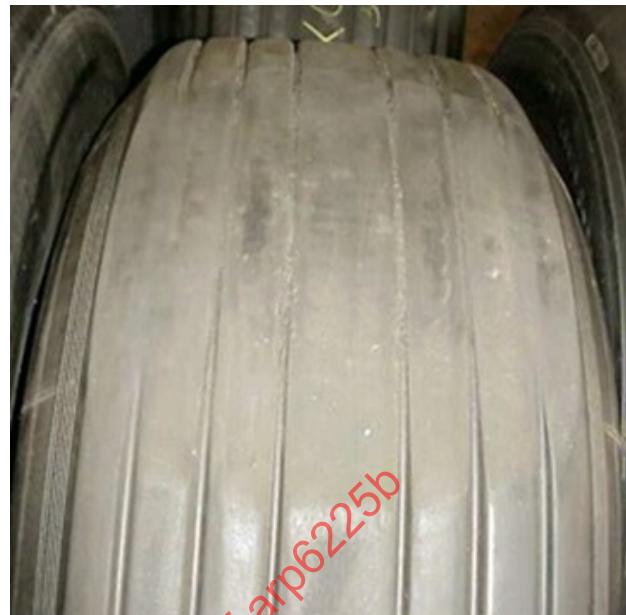
Figure 7 - Flat spot

Tread flat spot or severe tread rubber abrasion results from steering maneuvers prior to aircraft rolling, or the locking of the wheel during braking or touchdown (Figure 7).

Locked wheel tire flat spot

Typical tire flat spot

REMOVAL LIMIT: The tire should be removed from the aircraft when the flat spot damage exceeds the wear removal criteria of 5.1.

NOTE: The tire can remain in service if the flat spot does not reach the above-mentioned limit and if there is (1) sufficient groove depth in the whole flat spot area, or (2) no incipient (visible) separation.

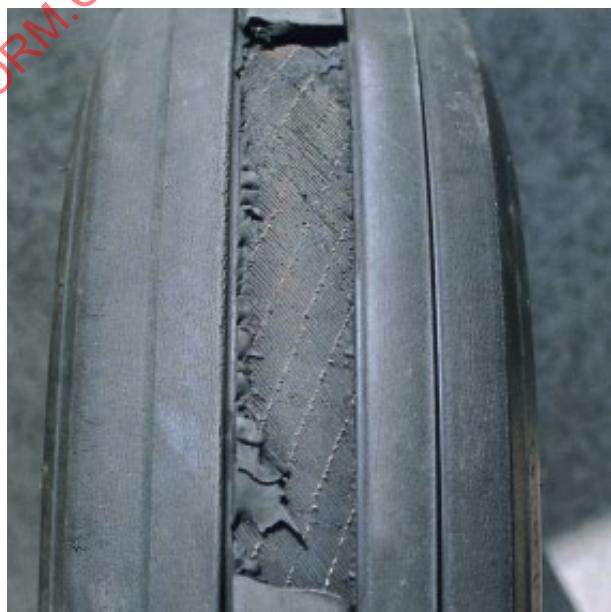
Figure 10 - Peeled rib

A peeled rib usually starts with a cut or damage in the tread and results in a circumferential delamination of the tread rib away from the tire casing, typically with no loss of reinforcing plies (Figure 10) or tire pressure.

REMOVAL LIMIT: The tire should be removed immediately from service when the peeled section, regardless of length, is exposing fabric or has fully detached. Pieces from the tread should be requested from airport authorities and returned to the home base for potential analysis by the tire supplier.

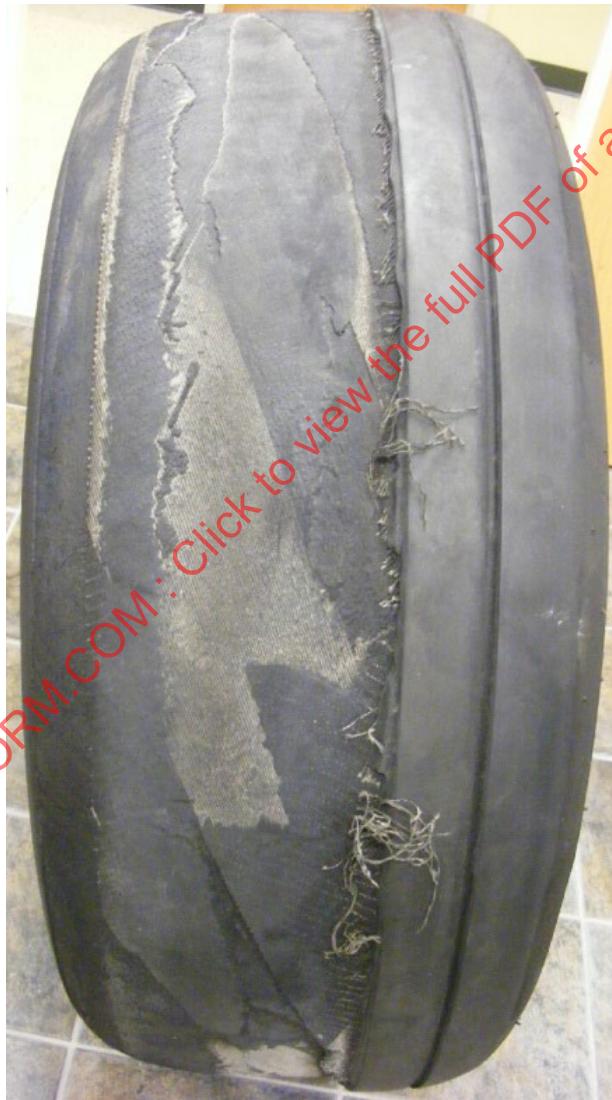
Figure 11 - Thrown tread

A thrown tread on an inflated tire is a partial or complete loss of the tread down to the casing plies or tread reinforcing plies/protector ply (Figure 11).

REMOVAL LIMIT: The tire should be removed immediately from service. Pieces from the tread should be requested from airport authorities and returned to the home base for potential analysis by the tire supplier. If the damaged tire is deflated due to a loss of inflation pressure, then the axle mate should be removed also.

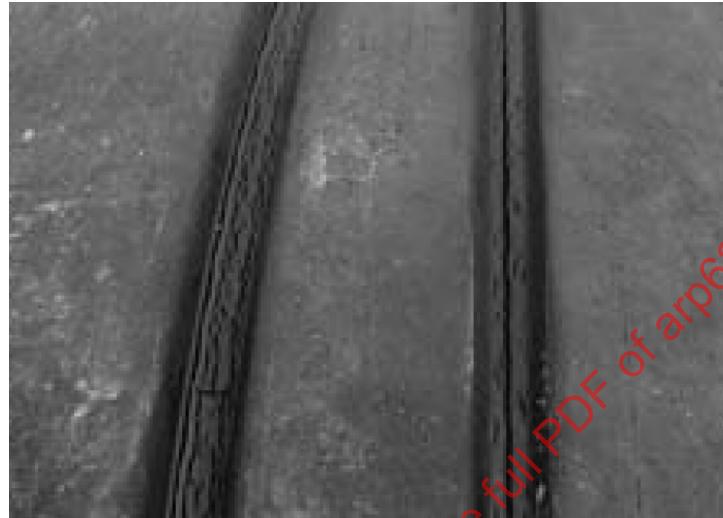
Figure 14 - Groove cracking

Groove cracking may result from ozone attack of the rubber or excessive flexing of the groove bottoms as a result of insufficient inflation of the tire. These cracks occur along the bottom of tread grooves (Figure 14).

REMOVAL LIMIT: The tire should be removed immediately from the aircraft if groove cracking exposes the fabric beneath the tread for more than 0.25 inch (6.35 mm) circumferentially in length or groove cracking has led to undercutting of the adjacent rib by more than 0.25 inch (6.35 mm).

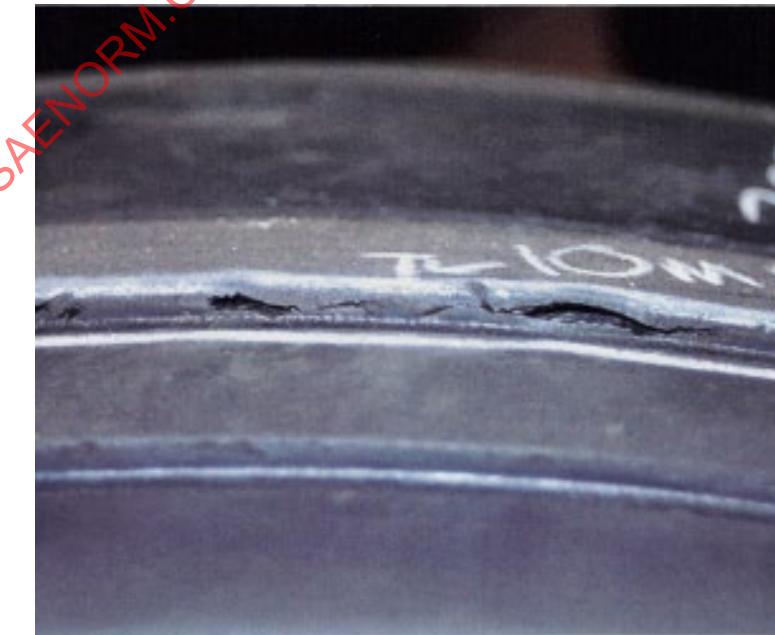
Figure 15 - Rib undercutting

Rib undercutting can be an extension of groove cracking progressing under a tread rib or develop as a break in the groove wall extending under the rib. This can lead to tread chunking, peeled rib, or thrown tread (Figure 15).

REMOVAL LIMIT: The tire should be removed immediately from the aircraft if undercutting extends more than 0.25 inch (6.35 mm) under the tread rib.

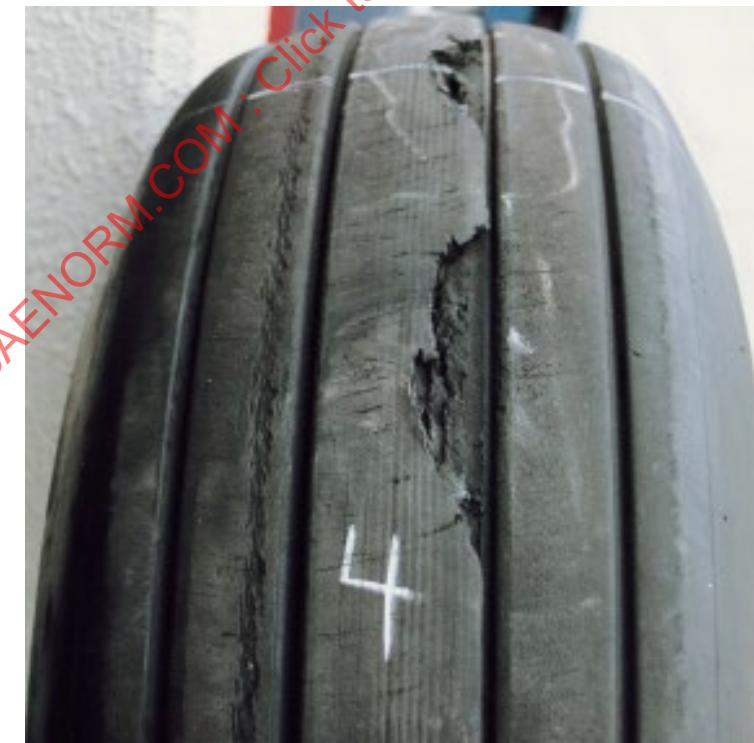
Figure 17 - Rib tearing

Rib tearing occurs when the tire is subjected to excessive side force during landing or taxiing (Figure 17).

REMOVAL LIMIT: The tire should be removed immediately from the aircraft if cords are exposed for more than 1.0 in² (6.45 cm²), or if the damage extends the full width of the tread rib.
